STRUCTURETECH ENGINEERING PC
Forensic Investigation Report

365 BROADWAY
NEW YORK, NY 10013

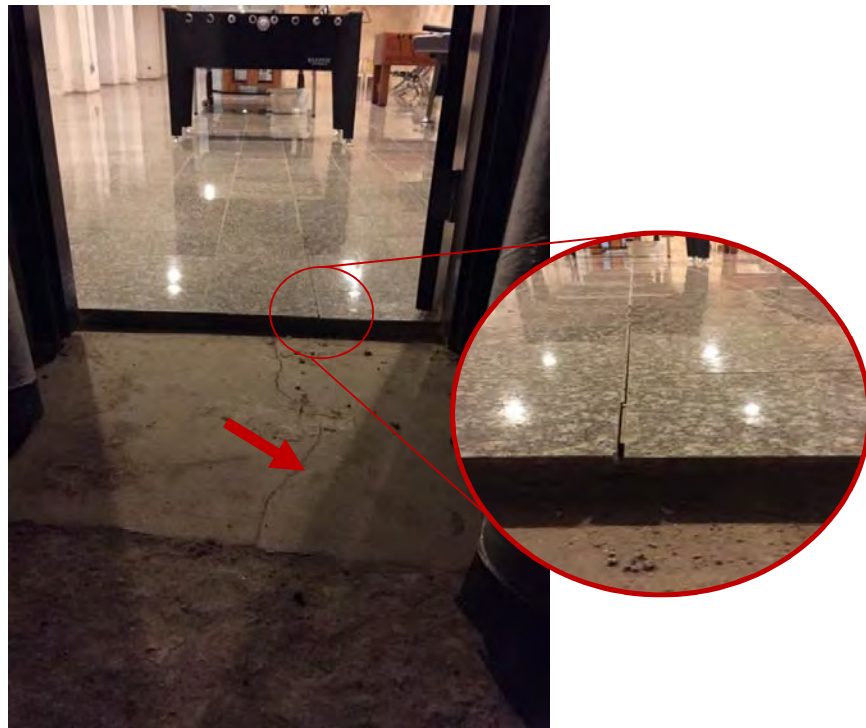
Photograph 11: Game Room and east vault: cracking noted in the Game Room concrete slab below the tile floor finish.

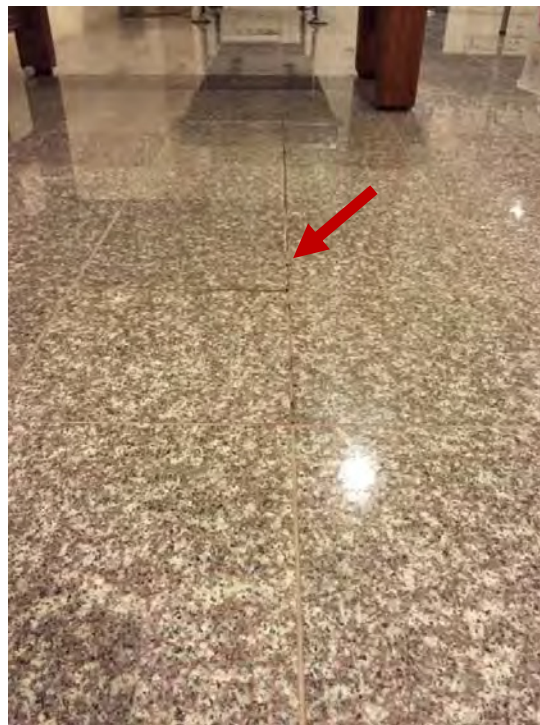
Photograph 12: Game Room: mortar joint cracks and through-tile cracks noted throughout the Game Room.

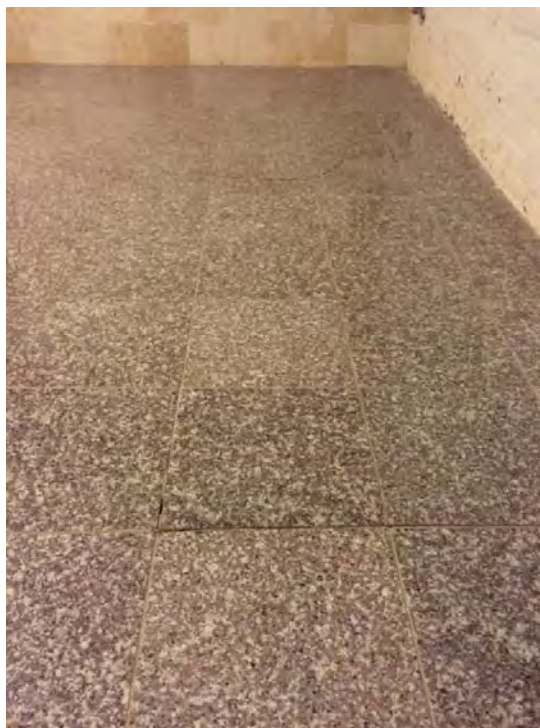
Photograph 13 mortar joint cracks and through-tile cracks noted near north wall

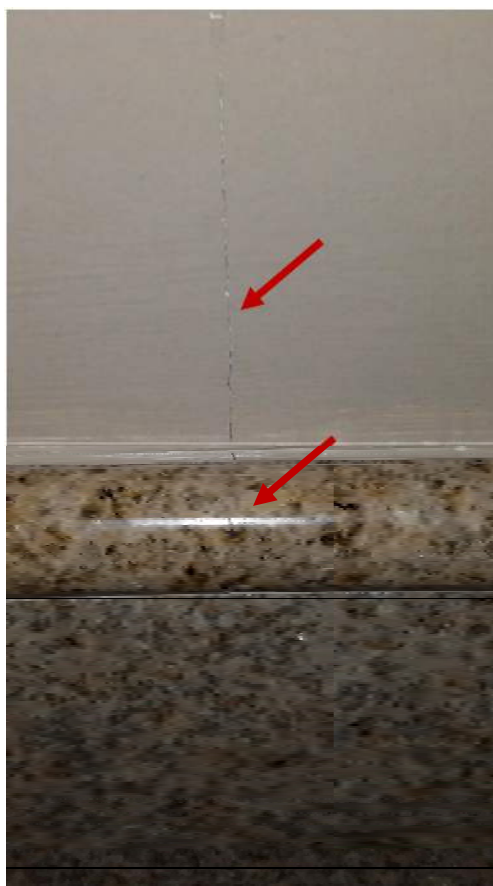
Photograph 14: Cellar level: crack noted in the wall and stone base at the north wall

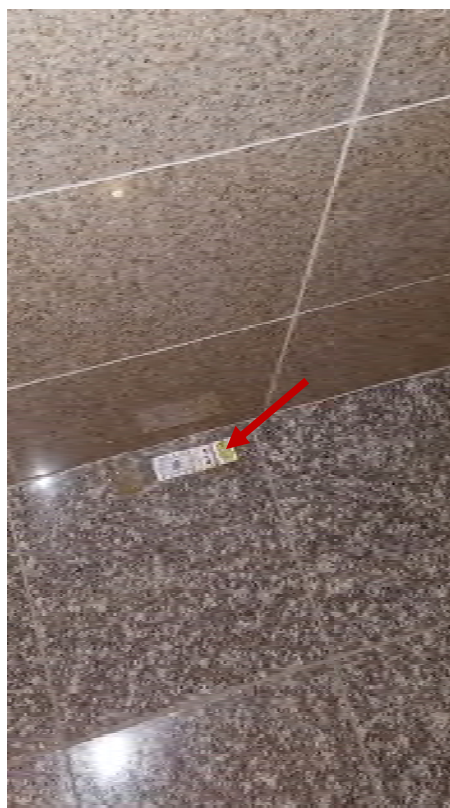
Photograph 15: Cellar level: crack noted in stone wall and floor at the north wall

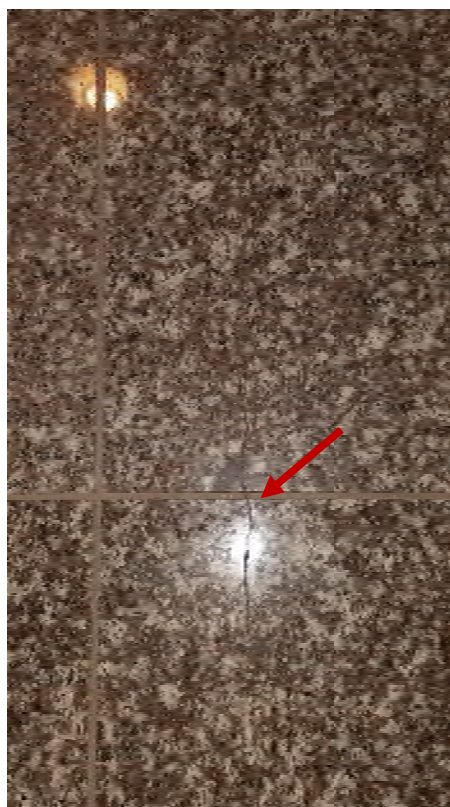
Photograph 16: Cellar level: crack noted in stone wall and floor at the north wall

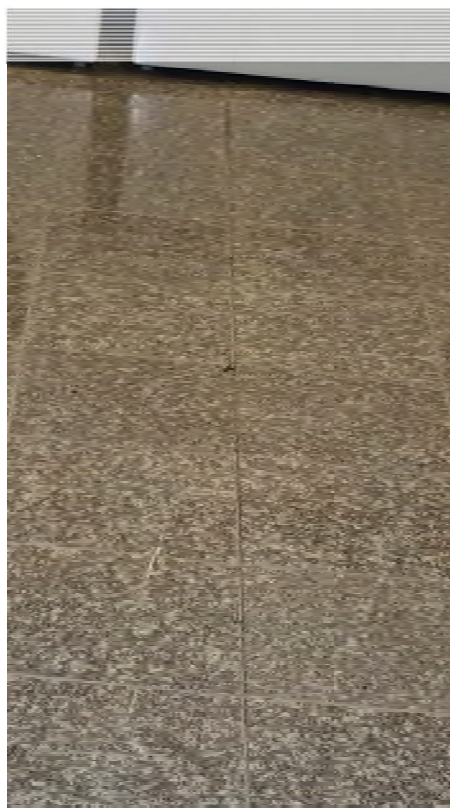
Photograph 17: Cellar level: crack noted in stone wall and floor at the north wall

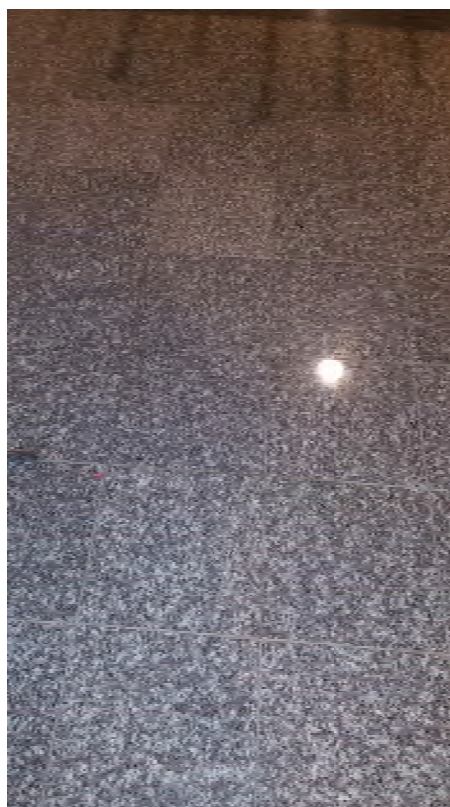
Photograph 18: Cellar level: crack noted in stone wall and floor at the north wall

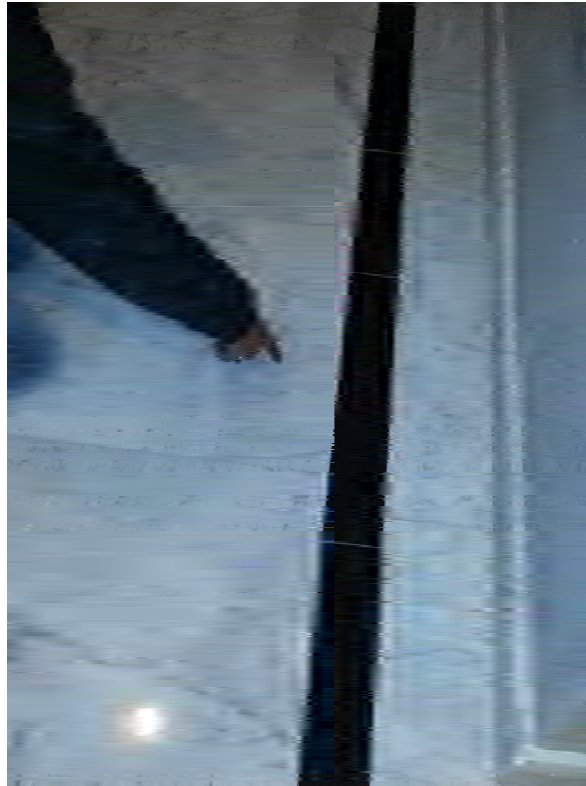
Photograph 19: First Floor: crack noted in the marble stone wall and floor at mail room

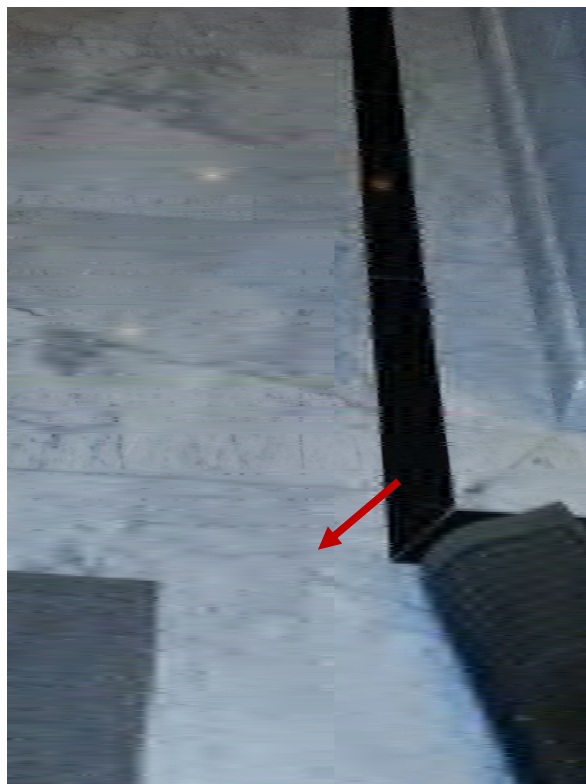
Photograph 20: First Floor: crack noted in the marble stone wall and floor at mail room

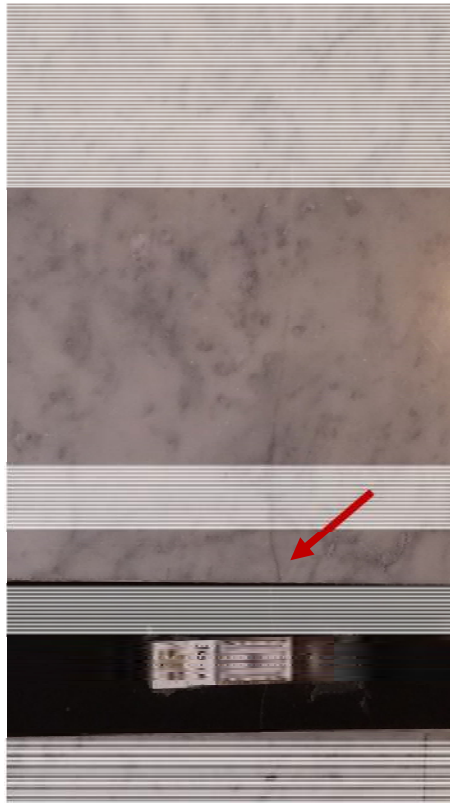
Photograph 21: First Floor: crack noted in the marble stone floor at mail room

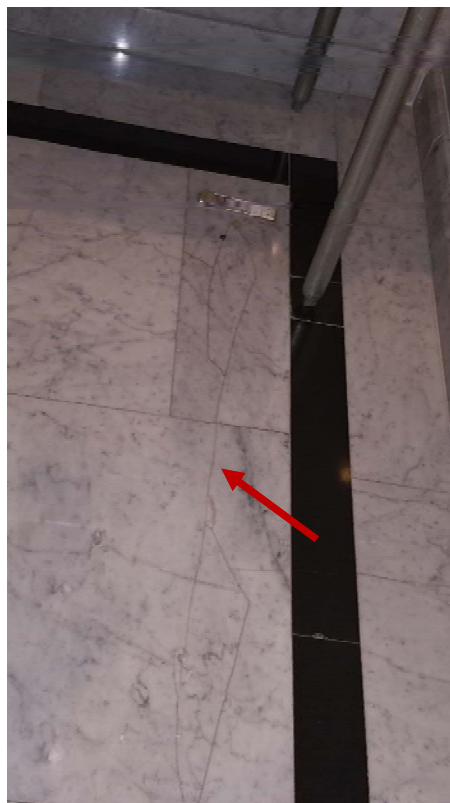
Photograph 22: First Floor: crack noted in the marble stone wall and floor at mail room

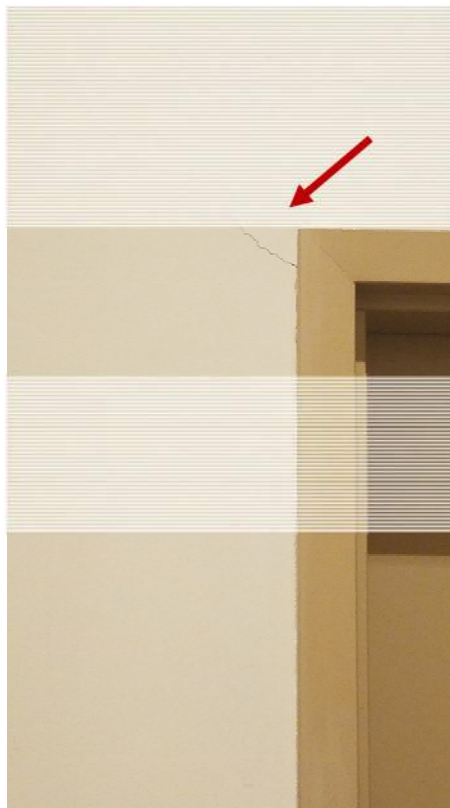
Photograph 23: First Floor: diagonal crack noted in the wall at the door of unit 2A

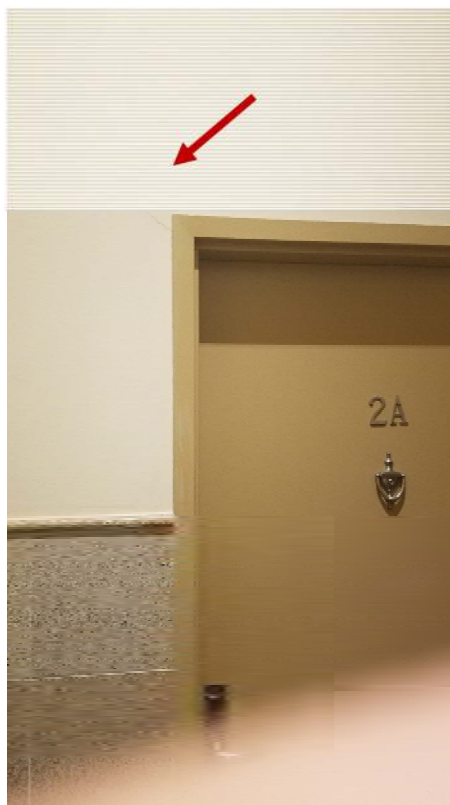
Photograph 24: First Floor: diagonal crack noted in the wall at the door of unit 2A

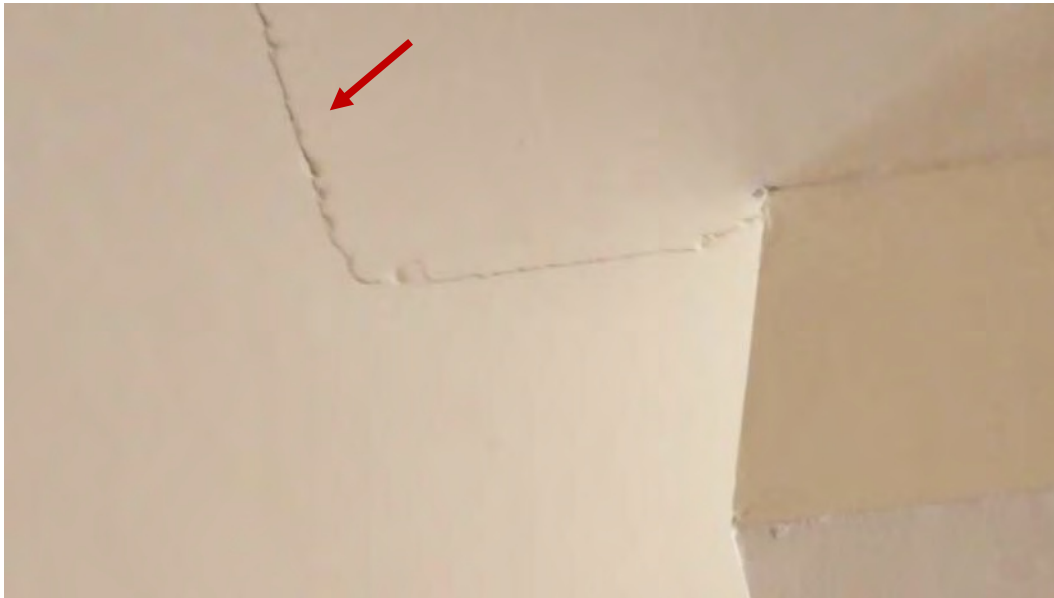
Photograph 25: First Floor: sheet rock crack noted in the ceiling of unit 2A

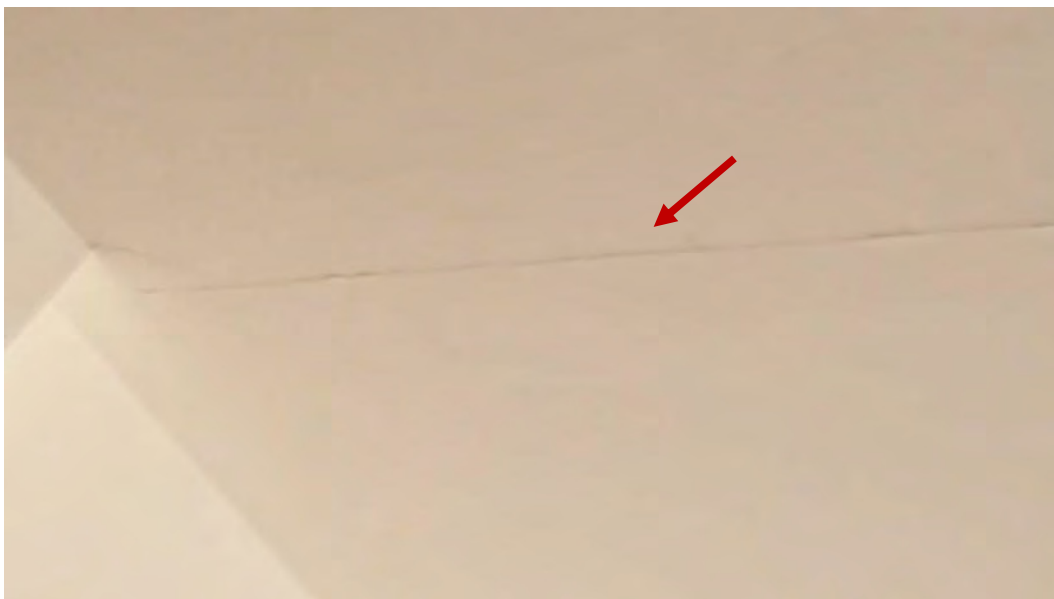
Photograph 26: First Floor: sheet rock crack noted in the ceiling of unit 2A

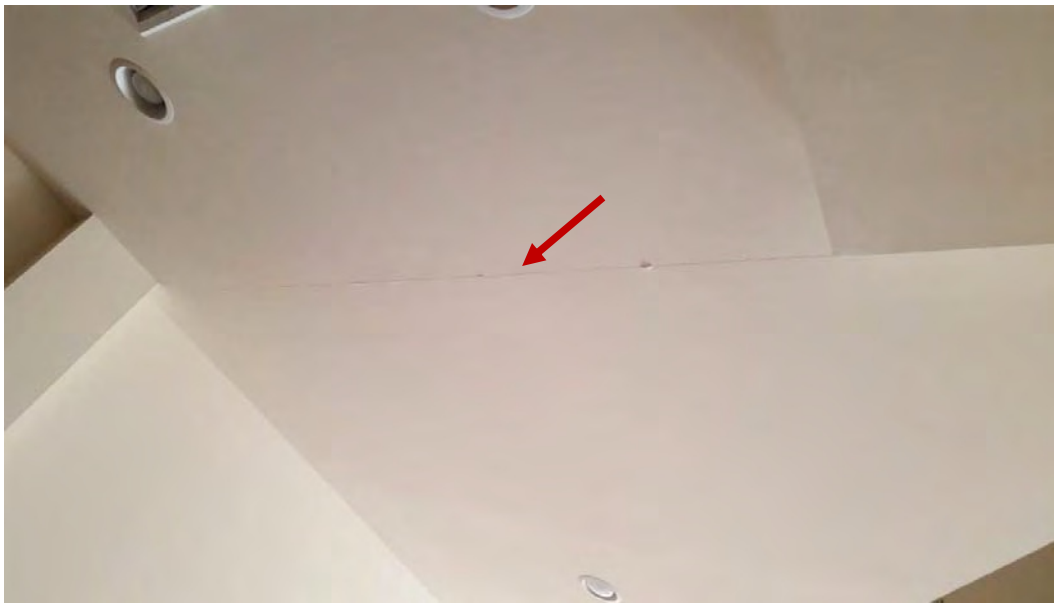
Photograph 27: First Floor: sheet rock crack noted in the ceiling of unit 2A

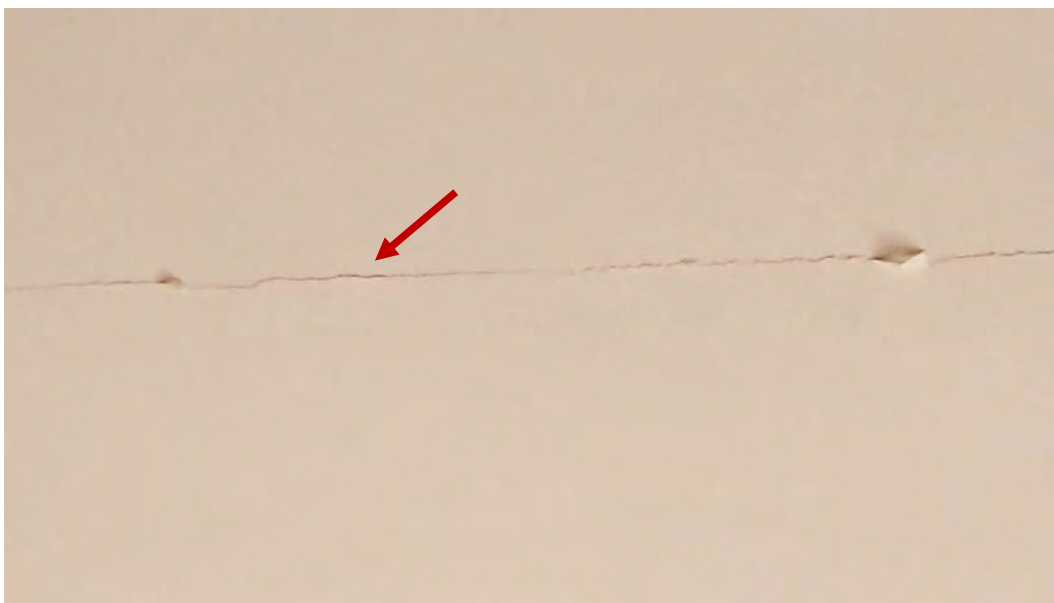
Photograph 28: First Floor: sheet rock crack noted in the ceiling of unit 2A

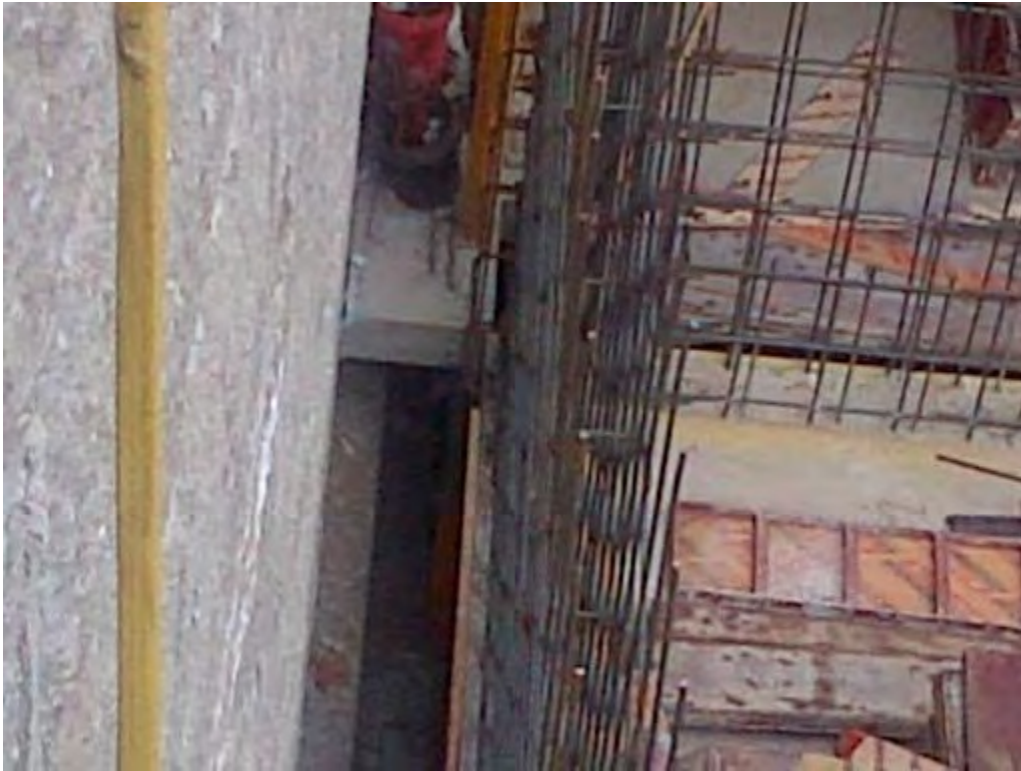
Photograph 29: North wall: the new building 371 Broadway has been built adjacent to 365 Broadway with no gap in between.
